Troubleshooting and Repairing RV Refrigerators

by Roger D. and Onna Lee Ford [Ford RV Service and Refrigeration Training Center]

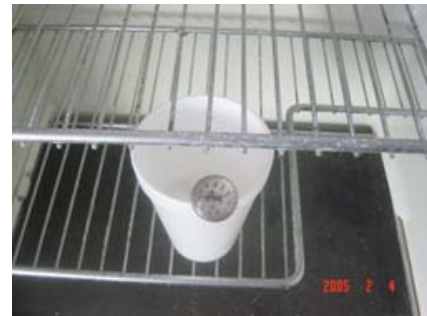
2. If you are using the temperature probe with a long stem or one similar to the one shown in the picture to the left, place it in a cup of water before beginning your testing. That way when you remove it from the refrigerator to read, you won't lose degrees too quickly. This gives you time to get an accurate reading.

1. We recommend you troubleshoot in 110V mode. We also recommend the use of a temperature probe in the refrigerator compartment. This will give an accurate temperature reading while eliminating the need to open the door to the refrigerator. We prefer our refrigerator temp to be approximately 35 degrees.

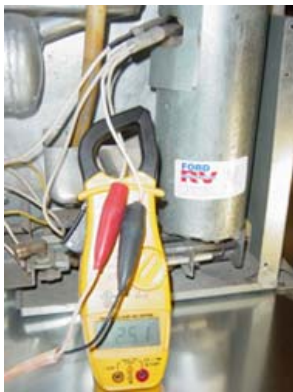
- With a multimeter clipped around one of the 110 Volt heat element wires (either one is ok), find the amperage reading. (ex. 2.6 Amps)
- Now take a voltage reading in the receptacle the refrigerator is plugged in to. (ex. 110V)
- Using Ohm's Law, take the voltage X amps to find the wattage.

Example: 110 Volts X 2.6 Amps = 286 Watts.

There is a 10% fluctuation allowance in either direction. So if the correct heat element for your make and model of refrigerator is 300 watts, 286 watts will work fine. If the result is more than 10% below or above the 300 watts, it needs to be replaced.

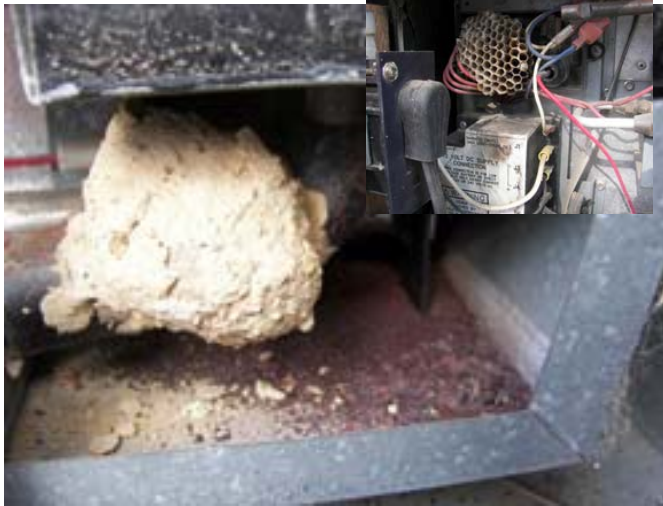
Wasp nest

Mud dobbers and wasps like to make nests on the backside of the refrigerator. Check for these and other debris that could cause problems.

Here's a little tip that will prevent critters from creating havoc around the lower vent. Remove the lower access door from the RV and lay it face down. Cut a piece of nylon screen a few inches larger in diameter than the actual size of the access door. Apply a bead of silicone around the inside perimeter of the access door. Press the nylon screening into the silicone

attaching the screen to the access door. Allow to thoroughly dry. Cut off any excess screening and reinstall the access door.

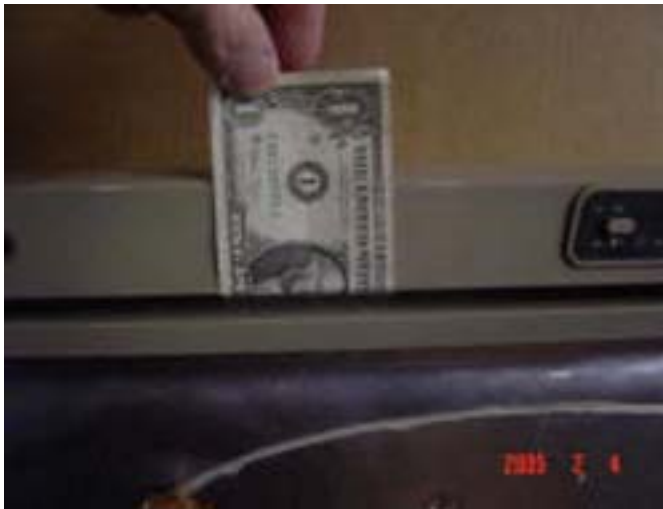
Often the lower part of the door gasket is the trouble spot. If visually the gasket looks good, check the seal by using a dollar bill. This is done by opening the refrigerator door and inserting a dollar bill between the gasket and the cabinet.

Close the door and pull the dollar away from the gasket. There should be some resistance showing a good seal. If there is little or no resistance, this indicates a poor door seal in this area. Repeat this step around the entire door gasket. Replace the door gasket if necessary.

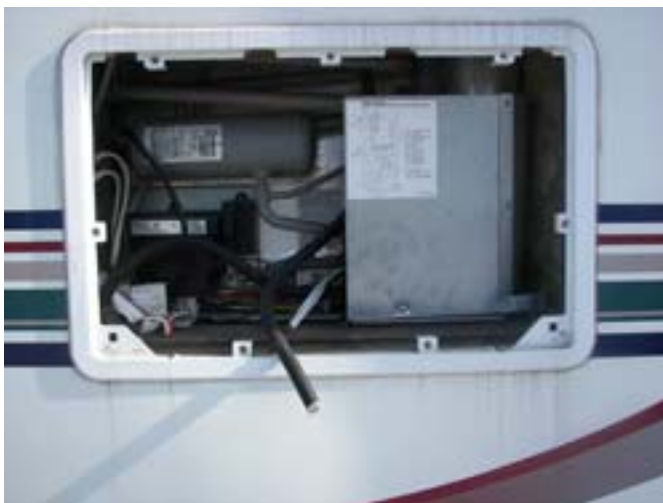
All refrigerators have a condensation drain. This consists of a tray located in the refrigerator compartment under the evaporator fins. When condensation forms on these fins, it drips into the tray. This is transferred to a drain hose attached near the bottom of the tray that passes through the back wall of the cabinet and down to the lower access door.

The backside of the cabinet, where the hose passes through the refrigerator cabinet should be sealed with putty or caulking. If this seal is poor, replace with a new one. Some have a drain hose that the end is pinched together so the water is just able to slowly drip out. Some newer models have the drain hose protruding through the access door with a small cap inserted into the end of the drain hose. This cap has many small holes.

This drain tube needs to have a "P" trap before exiting the lower access panel. Condensation drains are designed to allow condensation to escape and prevent ambient air from reaching the cooling fins.

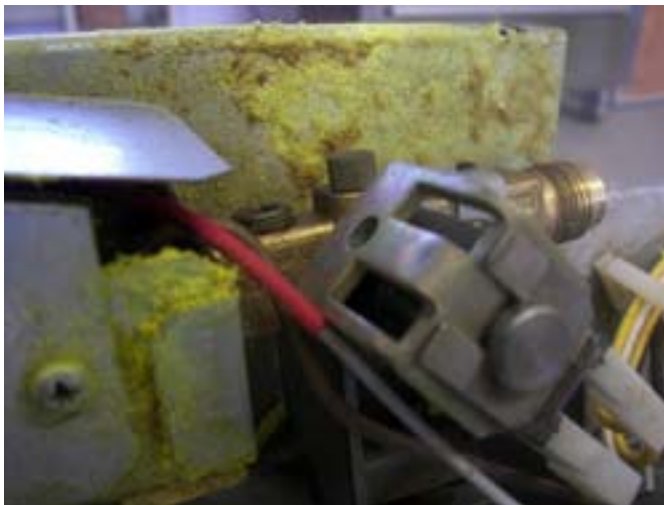
Chalky residue around burner

If you see this yellow chalky residue around the burner, or if you smell ammonia, the cooling unit has a leak. Contrary to what you might be told, the cooling unit can be successfully repaired and recharged. We have RV Refrigeration Network Associates (RVRN) across the USA and now in Canada who are RV Refrigerator Specialists. Having your cooling unit reconditioned by an RVRN Member will cost approximately half the amount of a new replacement cooling unit. Plus, instead of the limited warranty that comes with new units, you will receive a
